HIGH TIME SERVICE EVALUATION OF THERMAL BARRIER COATINGS
ON THE ROLLS-ROYCE RB211 ENGINE

F. Chris Toriz
Rolls-Royce Inc.
Atlanta, Georgia

Figure 6. - RB-211 service evaluation of engine build no. 2 with 2539 hr/1353 cycles.

Figure 9. - RB-211 service evaluation of engine build no. 1 with 4106 hr/2271 cycles

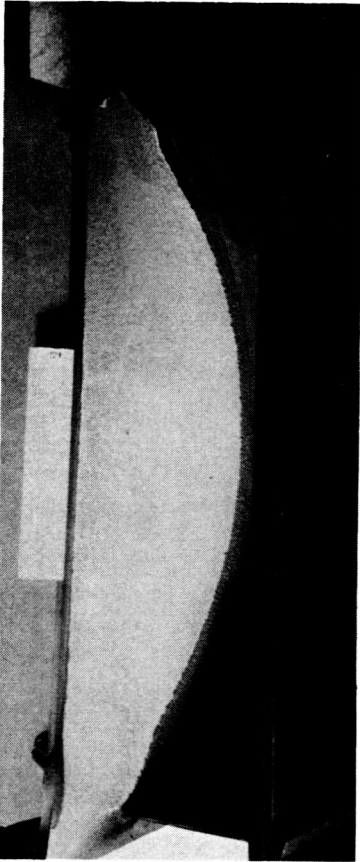
3 Layer Mag. Zirc (Typical)

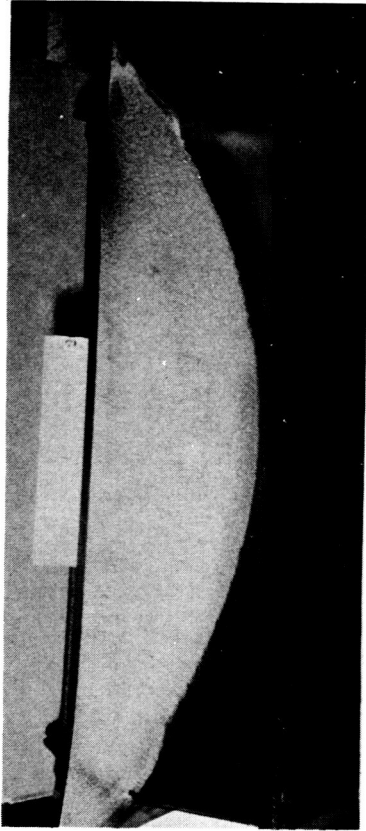
2 Layer Mag. Zirc (Typical)

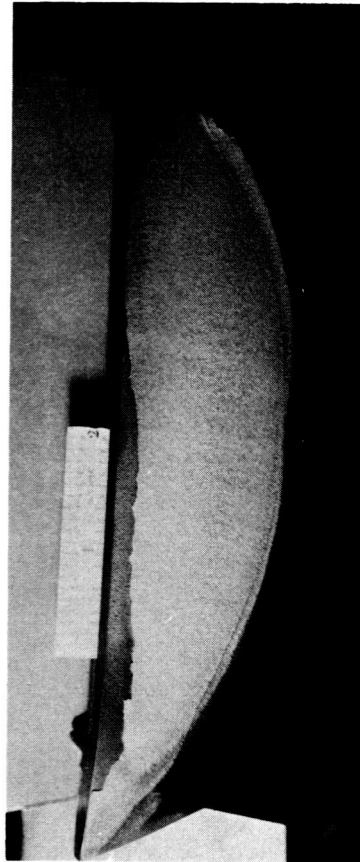
3 Layer Mag. Zirc (Worst)

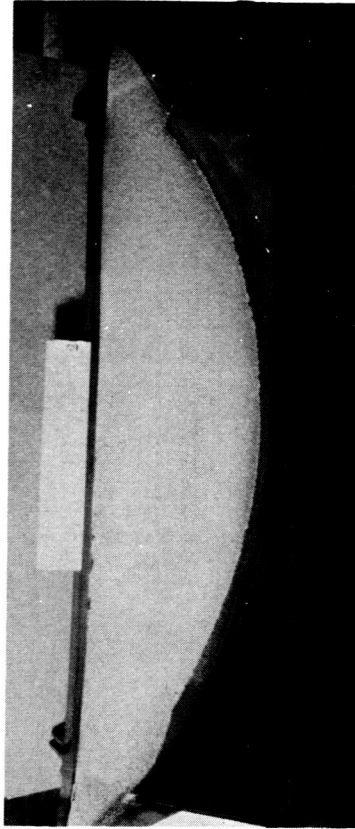
2 Layer Mag. Zirc (Worst)

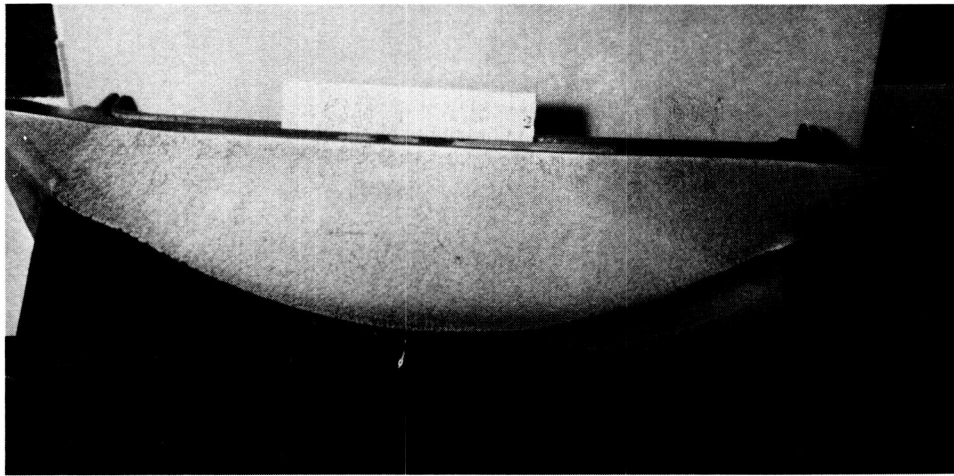
METCO 443 + YSZ (Typical)

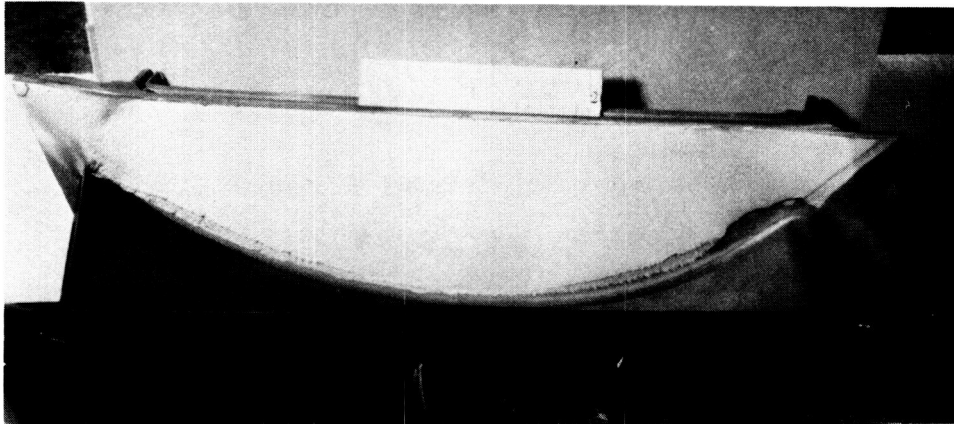
LPPS MCrAlY + YSZ (Typical)

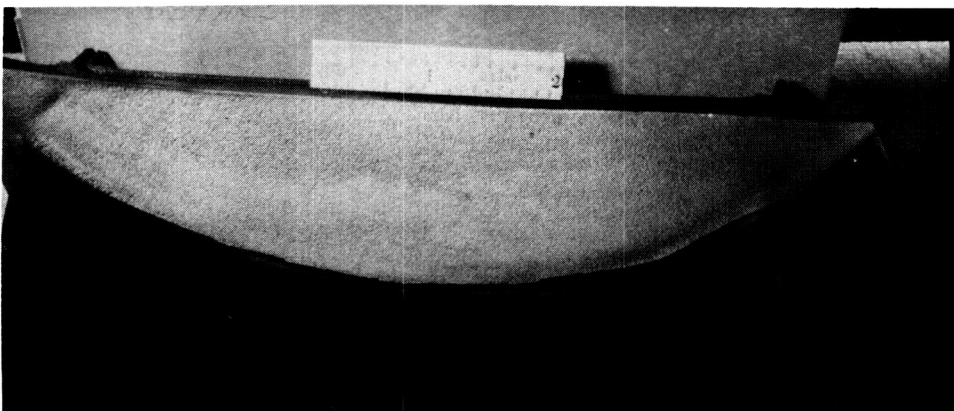
Argon Shrouded MCrAlY + YSZ (Typical)

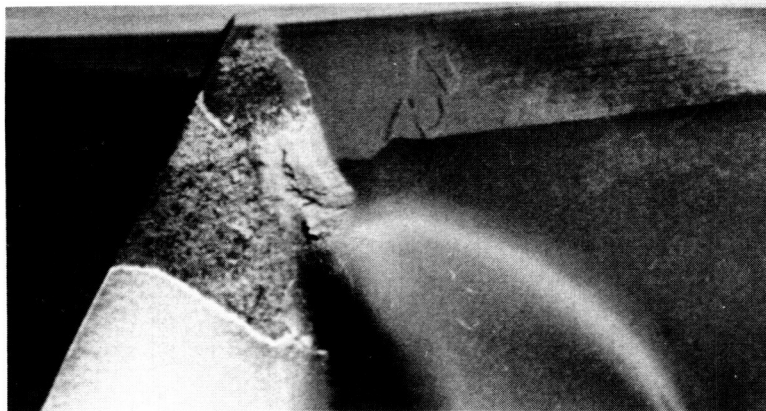
2 Layer Mag. Zirc (Worst)

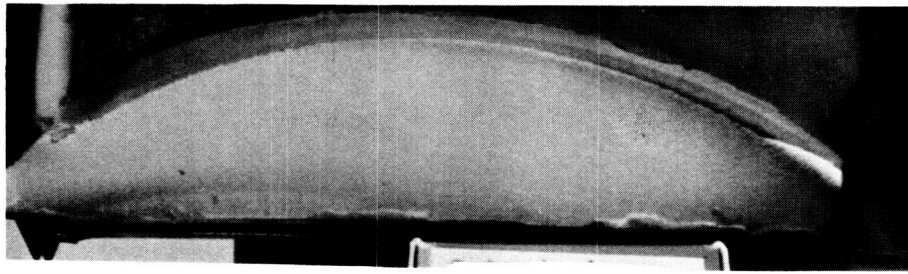
2 Layer Mag. Zirc (Typical)

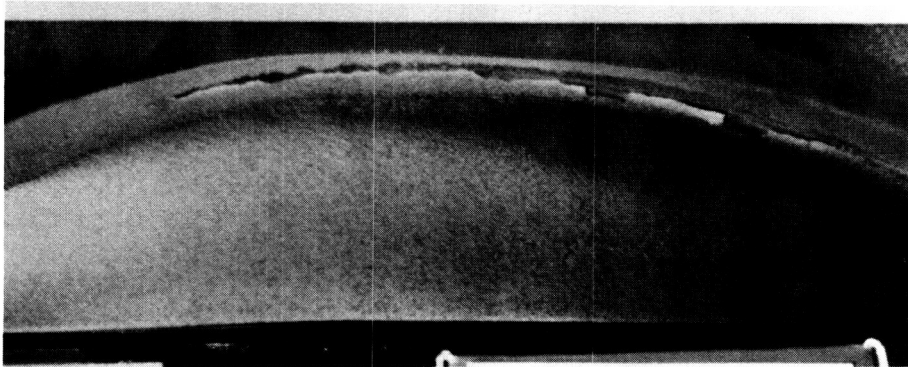
METCO 443 (Worst) + YSZ (Typical)

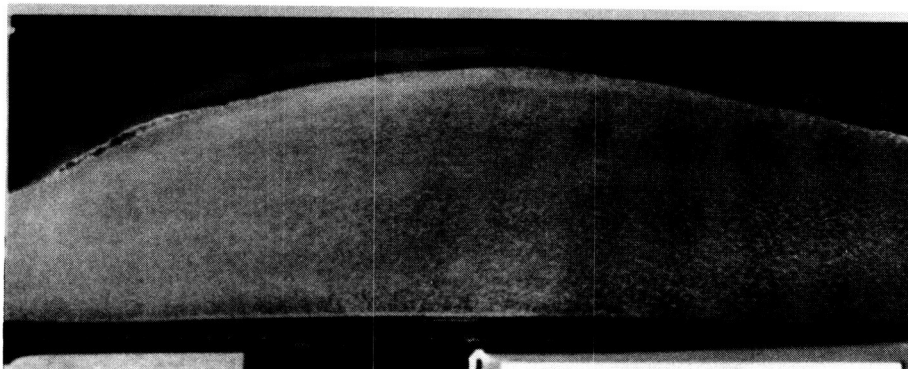
Argon Shrouded MCrAlY + YSZ (Worst)
